Investigation of Fiber-Reinforced Polymer for Seismic Rehabilitation of Concrete Structural Frames With Unreinforced Masonry Infill

Ghassan K. Al-Chaar, Justin B. Berman,
and Steven C. Sweeney

May 2003

ERDC/CERL TR-03-10

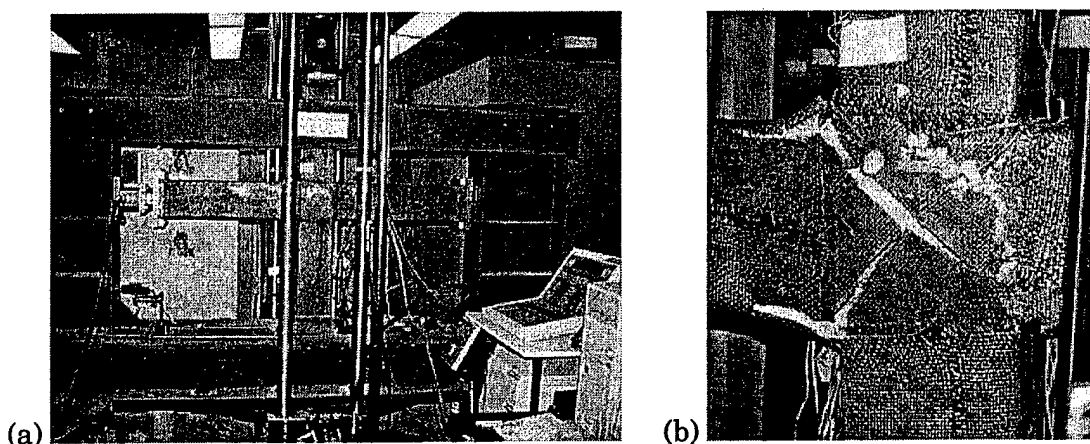
Figure 4.6. Test setup (a) and failure mode (b) of wrapped beam-column joint.

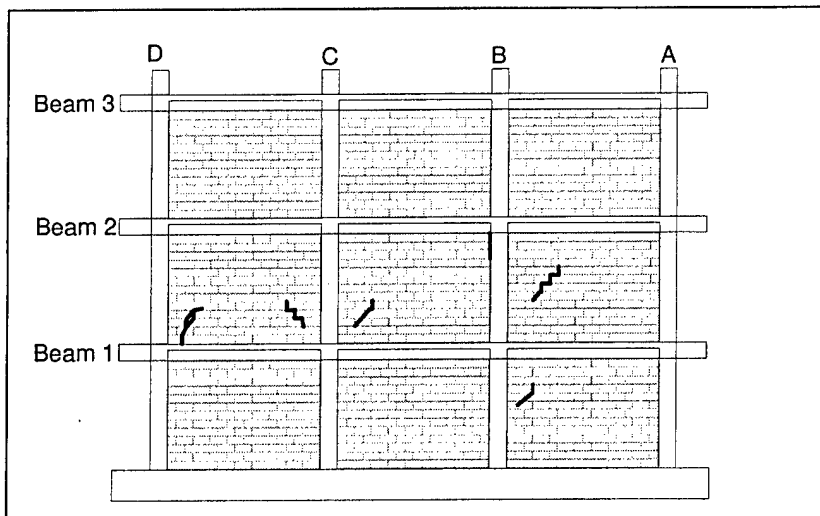
Using the identification scheme shown in Figure 5.1, Model 1 was loaded using a modified CUREE method, cracking the wall throughout 40 cycles spread over 3 hours. The first cracks appeared during the positive stroke of cycle 21 at a maximum test load of 14.17 kips on the top floor. All but one of the cracks occurred on the second level, and most of those were diagonal cracks on the left half of the three panels, as shown in Figure 5.2. A number of the diagonal cracks were a combination of stair-stepping cracks through the mortar and cracked CMUs — mostly at an angle through corners. At this time, the first indication of the masonry separating from the column appeared in the upper-right corner of panel 2B, where a vertical crack formed between column B and the CMUs. Throughout the rest of the test the second floor continued to crack the most, with the highest crack propagation occurring in the corners of the bottom six panels and along bed joints.

Figure 5.2. First cracks, cycles 21 through 24.

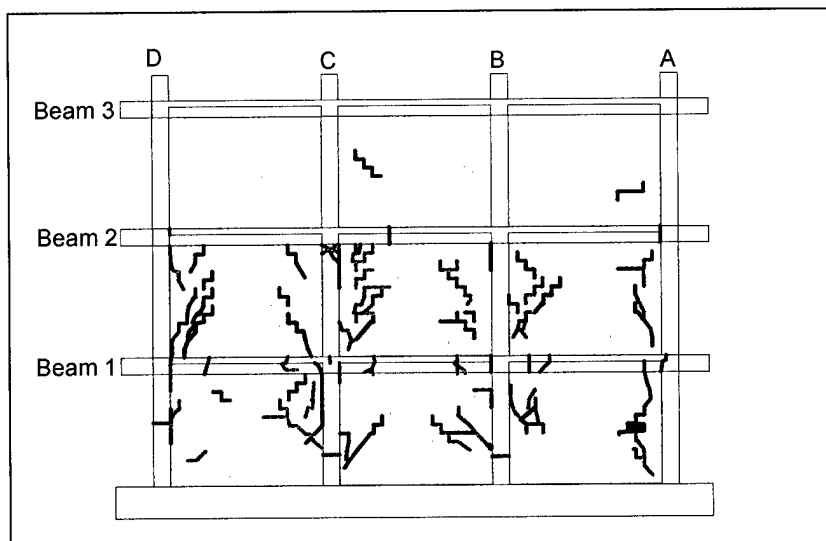
The following series of cycles, 35 – 37, continued to damage the infilled frame. With the drift ratios over 1% in both the first and second floors, the load capacity dropped from 13.48 kips in the positive stroke of cycle 32 to 12.02 kips in the positive stroke of cycle 35 for the third story, the largest drop in load yet. During this series, stair-stepped cracks in the third-story CMUs were observed while columns 1B, 1C, and 1D sustained flexural cracks (Figure 5.6). The top of column 2C, which was initially cracked in shear during cycle 32, accumulated further damage. There was also some evidence of bed joint sliding in the bottom six panels, but none of these cracks had propagated farther than two or three CMU lengths. The last major change was the development of cracks in the first and second beams. The first beam cracks took place early, during cycle 29, and four more major cracks appeared after cycle 32.

Figure 5.6. Cracks appearing during cycles 35 through 37.

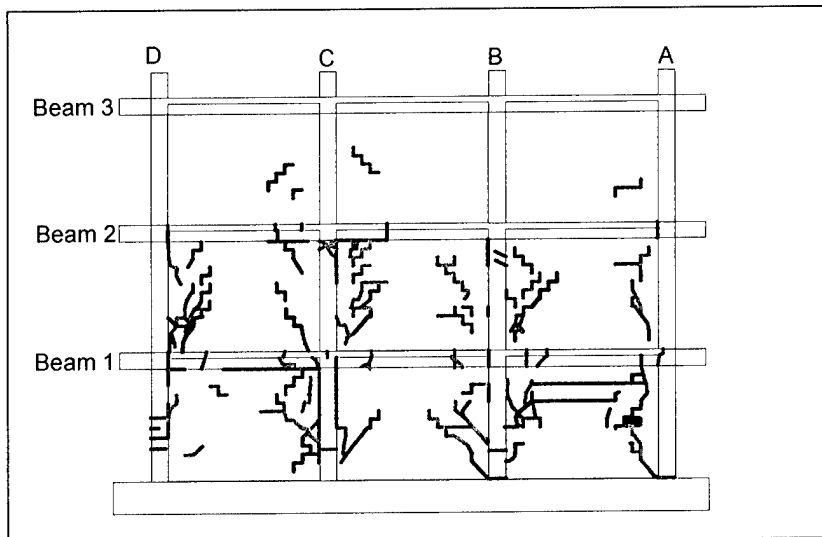
The damage from the last series of cycles, shown in Figure 5.7 and Figure 5.8, was fairly significant. At a maximum third floor displacement of 3 in., the drift ratios of first and second floors were over 2%, and the third floor drift ratio approached 0.5%. Columns 1C and 1D sustained more flexural cracking at mid-height, and columns 1A and 1D cracked at the base. Panels 1C, 2B, 2C, 3B, and 3C started to separate from the frame, and the second beam continued cracking above panel 2C. Bed joint cracks were found after the test in every panel; the first and second floor panels were so severely damaged that the masonry was loose to the touch. Load capacity continued to drop with increased deflection. Cycle 38, the peak displacement cycle, had a load capacity of 10.94 kips at the third story, over 3 kips less than peak load. Although column and beam joints remained intact and the frame preserved its original shape, damage of the overall structure could be described as severe. The masonry had lost most of its cohesiveness and almost all the mortar was cracked. Only panel 3A remained partially solid.

Figure 5.7. Cracks appearing during cycles 38 through 40.

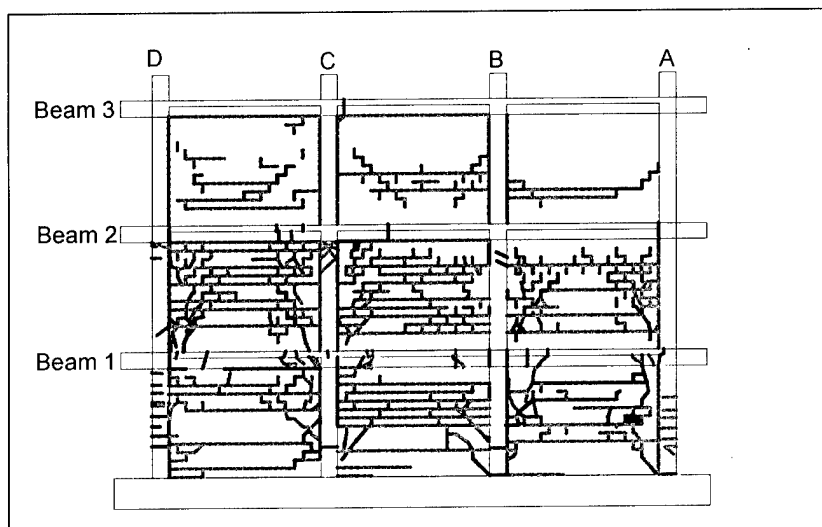
Figure 5.8. Cracks found after completion of test.

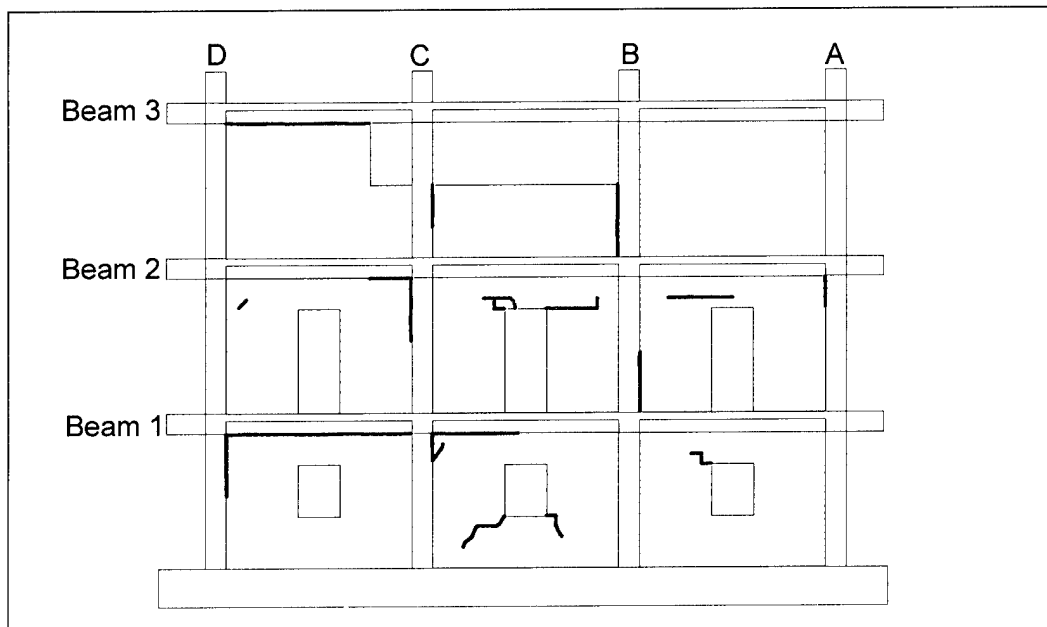
The first cracks appeared during cycle 25 with a maximum load of 23.0 kips on the third floor. Figure 7.2 shows that cracks appeared in all but panel 3A. Most of the cracks occurred in the mortar. Cycle 25 is also when the masonry started to separate from the columns and beams in panels 1B, 1C, 2A, 2C, 3B, and 3C. Throughout the remainder of the test, the first floor cracked the most, with a majority of these cracks initiating out of the corners of the window openings.

Figure 7.2. First cracks, cycles 25 through 28.

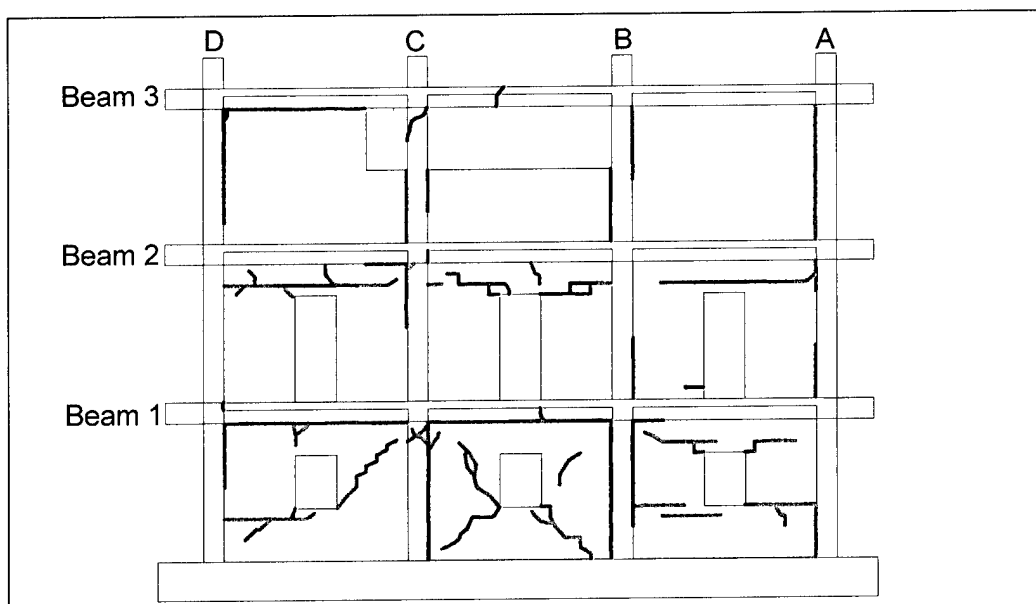
New cracks formed in the panels through cycle 32. At this point many of the new cracks, and extensions of the existing ones, started to propagate through the bricks instead of following the mortar joints. The first floor had the greatest number of new cracks (Figure 7.4) due to the rapid increase in the strain in the panels. While the first and second floors had of cracks forming in the panels, the third floor had slight separation of the panels from the concrete frames. The third floor did not have enough strain to initiate any cracks in the masonry panels, but the drift ratio of the third floor was about 0.05% — enough to cause the panels to separate from the concrete frame.

Figure 7.4. Cracks appearing during cycles 32 through 34.

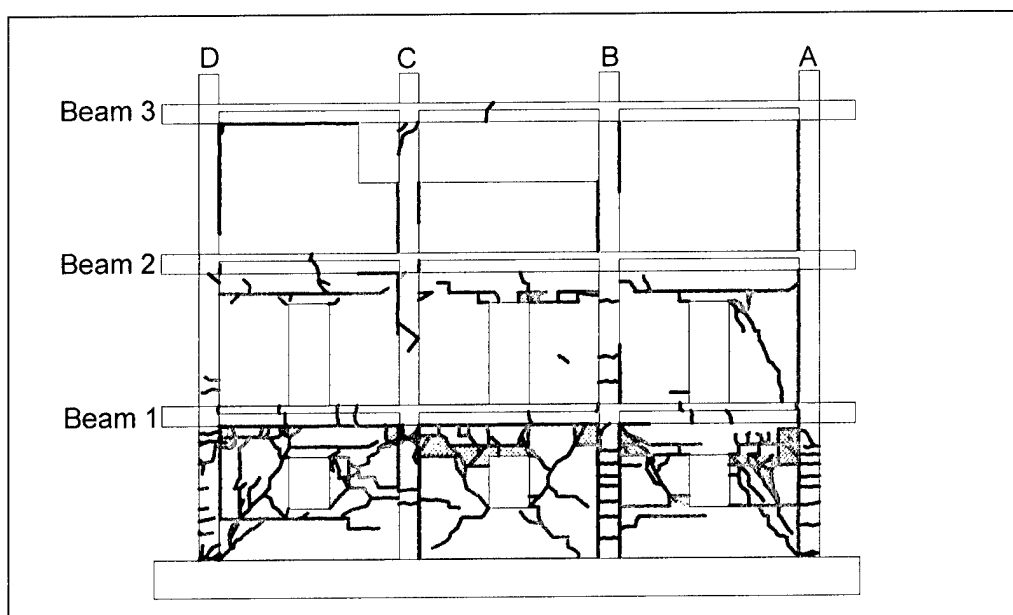
Figure 7.7. Cracks found at the completion of the test.

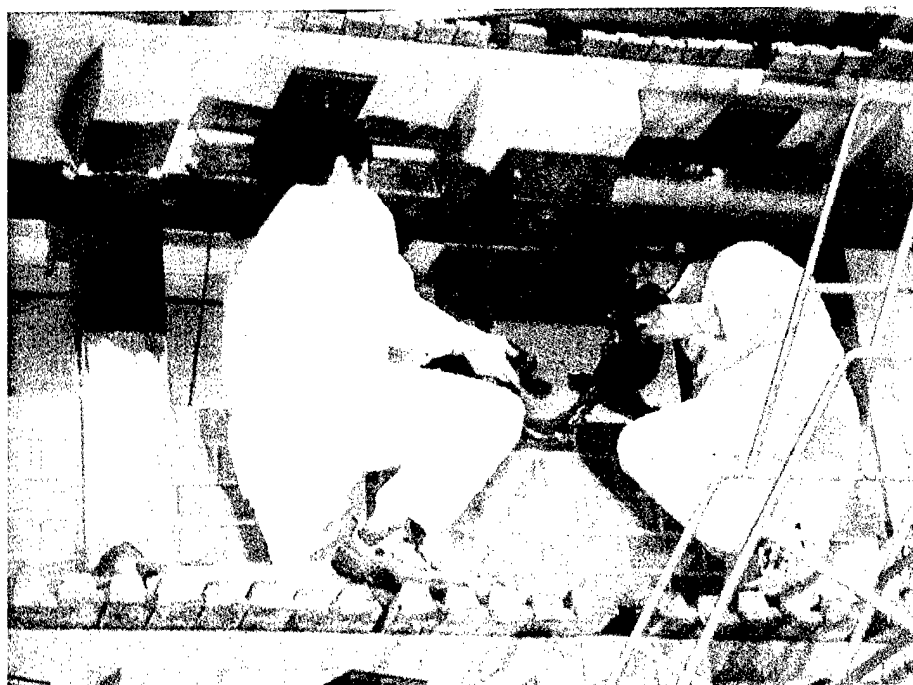
Figure 8.2. Repairing of the third story column and beam.

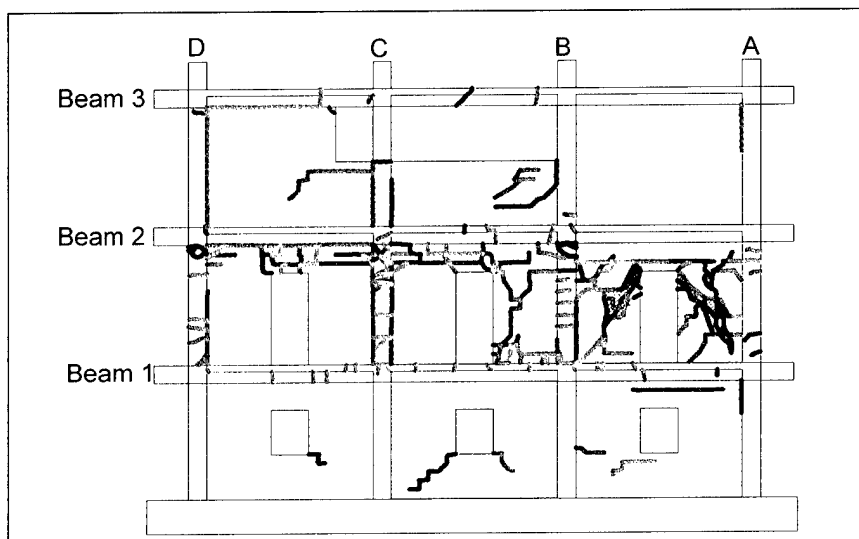
Figure 8.12. Cracks found at the completion of the test.
